**Bare Mitigation Site  
Unnamed Tributary to Peak Creek, Ashe County**

**Monitoring Report**

**NORTH CAROLINA DEPARTMENT OF TRANSPORTATION  
STREAM MITIGATION PROGRAM**

**Period covered October 22, 2002 to July 7, 2004**

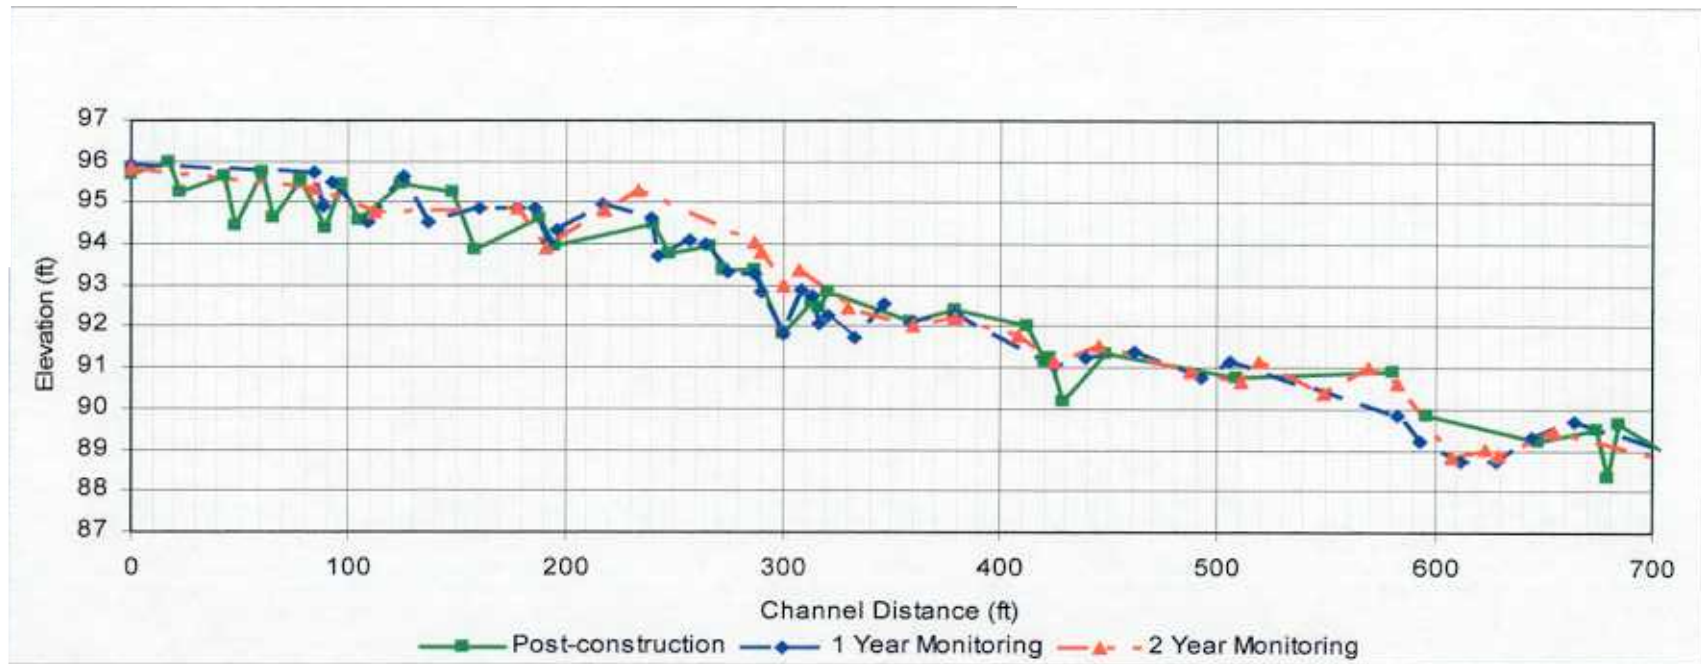
FIGURE 2.1. Longitudinal profile comparisons from station 0+00 – 7+00 feet.

Since construction was completed in September 2001, several channel adjustments have occurred to the longitudinal profile (Figure 2). The 2002 monitoring survey shows that the stream bottom aggraded along a series of small rock vanes from stations 0+17 to 0+89, filling in the small constructed pools (Figure 2.1). In 2004 this section degraded slightly towards post-construction elevations, however, the pools were not reestablished. The aggrading that took place in the constructed pools in this section was not unexpected. The rock vanes constructed in this area were an experiment to see if pools could be created along this reach utilizing riprap placed on the streambank by the landowner years ago. Apparently, the stream grade through this area was too low and the bed load settled out in the constructed pools.

As a result of the November 19, 2003 storm event, a major change occurred in the longitudinal profile from stations 1+12 to 2+33 (Figure 2.1). During this storm event, bed load materials began to deposit in the channel at station 2+33, causing a side channel to develop across a point bar upstream at station 2+18. As this new bar channel deepened, stream velocities were reduced in the main channel and additional streambed materials began to be deposited in the main channel from stations 2+33 to 3+30 (Figure 2.1). At station 3+30 the new bar channel connected with the main channel. From station 3+30 to the end of the project some minor differences between the 2002 and 2004 longitudinal surveys can be noted (Figures 2.1, 2.2 and 2.3). At station 18+75 a new, deep pool was formed and from stations 19+54 to 20+26 an existing pool was filled in by streambed materials. These changes are a direct result of the November 19, 2003 flood (Appendix 1). Repair work was completed on July 7, 2004 from station 2+33 to 3+30 to reshape the point bar and eliminate the newly formed bar channel.

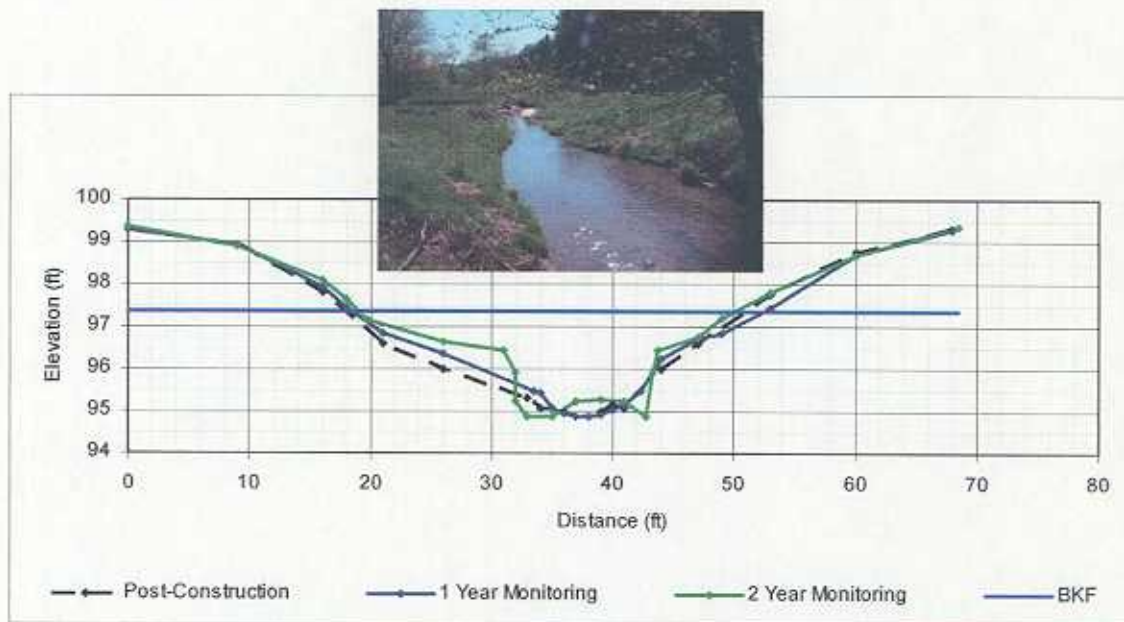
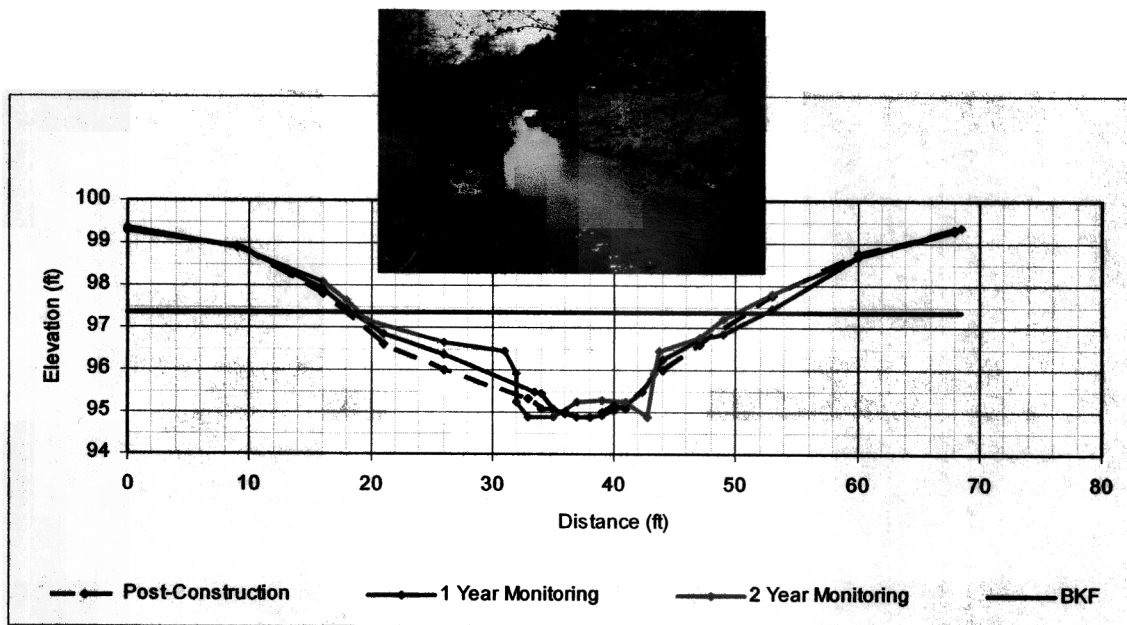
FIGURE 3.1. Cross-section station 1+78, pool.

**CROSS-SECTION 1+78 - pool (Figure 3.1):** This cross-section is located over a long pool. There have been some changes in this cross-section profile from 2001 to 2002 as a result of the November 19, 2003 flood. The left bank has increased in height approximately 1.4 feet near the waters edge. This is a direct result of the flood depositing bed materials along this area. The center thalweg has been eliminated due to a 0.37 ft rise of the mid-section of the stream channel, causing a shift in the thalweg to the left and right banks. These changes have not caused channel instability as the banks exhibit stable elevations and breaks in slope.

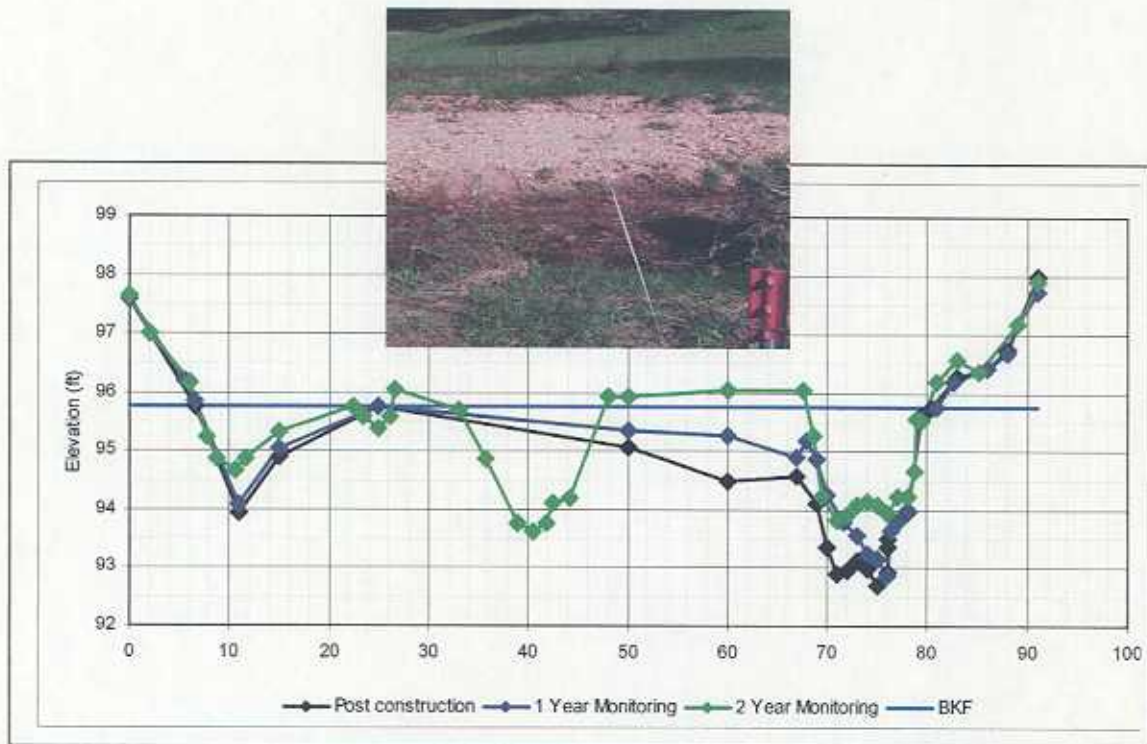
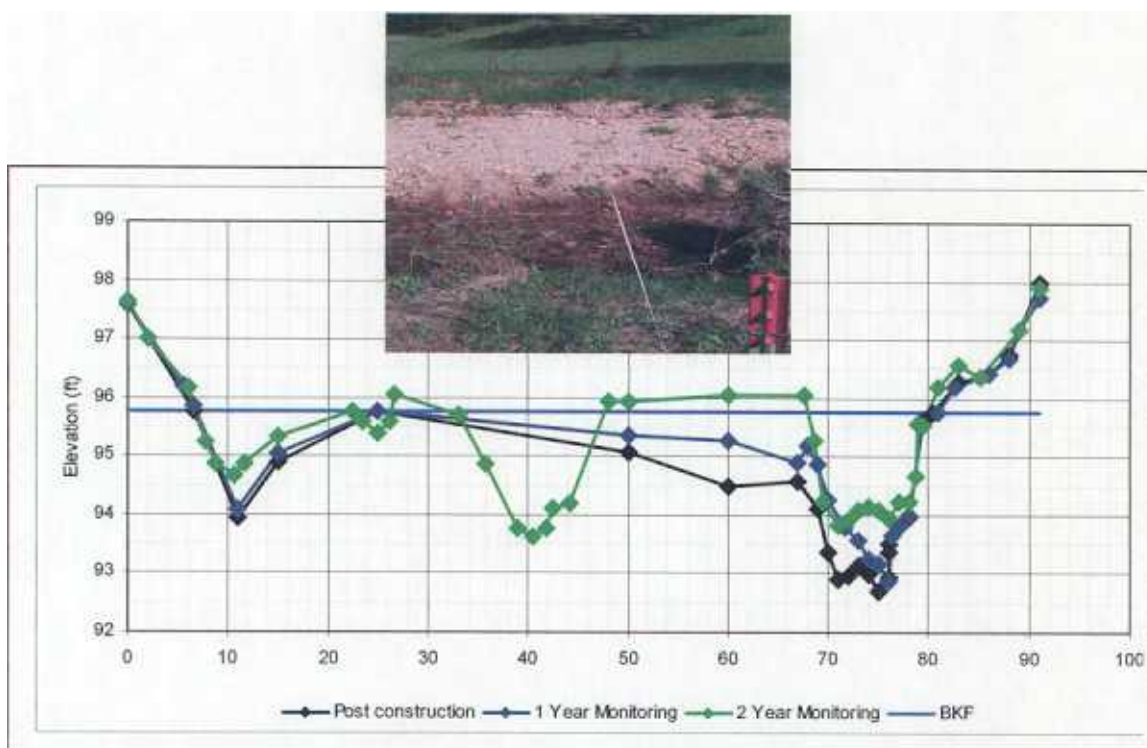
FIGURE 3.2. Cross-section station 2+90, riffle.

**CROSS-SECTION 2+90 – pool (Figure 3.2):** This cross-section is located over a meander pool stabilized by root wads. The left and right banks have remained stable but some major changes have occurred across the wide point bar. The November 19, 2003 flood created a 15 ft wide head cut and resulting channel across the bar from stations 0+33 to 0+48. This head cut channel does not extend all the way across the bar, but the potential exists for it to do so over time. If this occurs the meander and pool at this location would be eliminated. Deposition from the November 19, 2003 flood increased the height of the bar 0.87 ft from stations 0+48 to 0+67.7 and filled in the pool at the base of the root wads 1.07 ft. This area was repaired on July 7, 2004 by reshaping the point bar to eliminate the new channel.

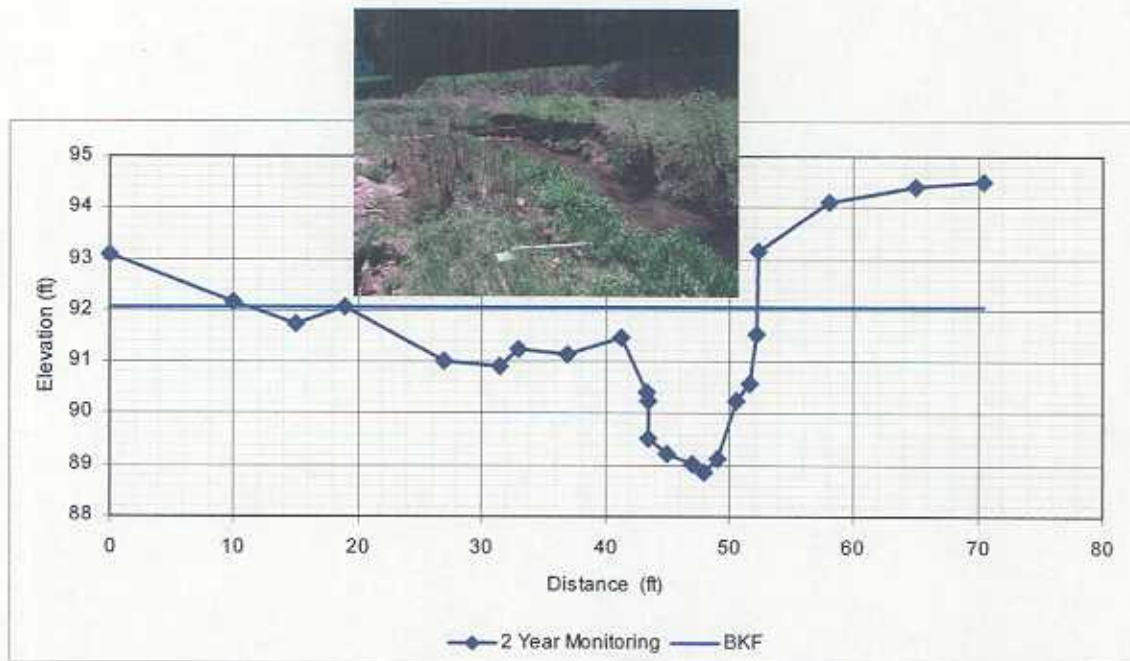
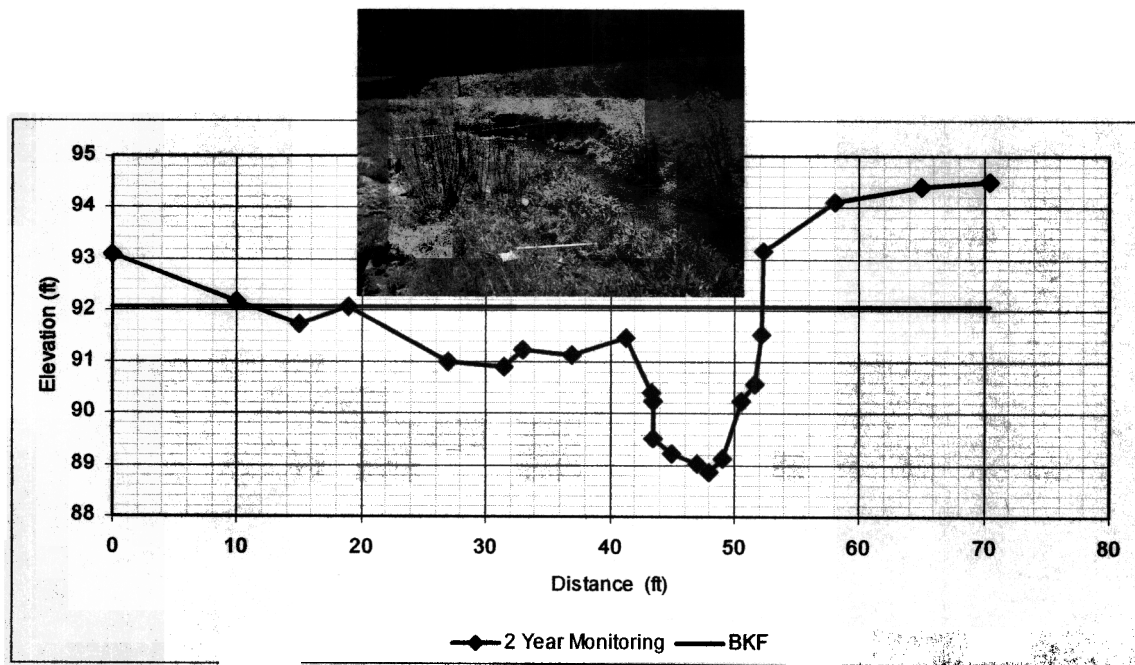
FIGURE 3.3 Cross-section station 6+29, pool, a new cross section in 2004.

**CROSS-SECTION 6+29 – pool (Figure 3.3):** This is a new cross-section located over a pool on a section of eroding bank that developed after the November 19, 2003 flood. The bank had never been a problem until this flood event. This cross-section was established to monitor the eroding bank and to monitor repairs to the bank that were completed on July 7, 2004.

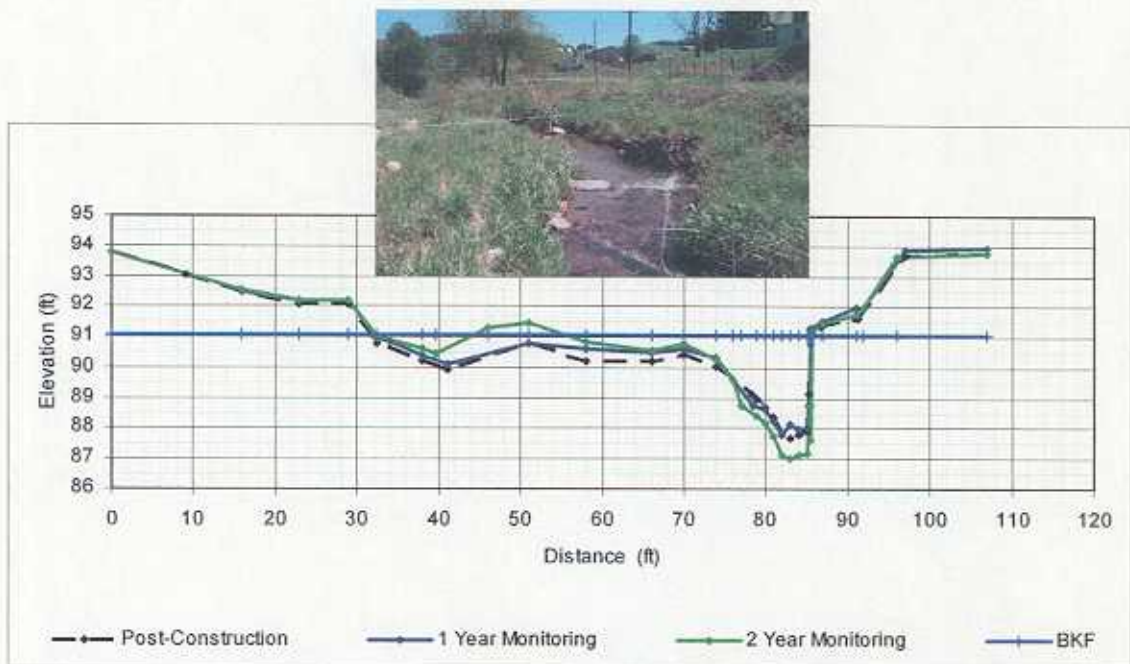
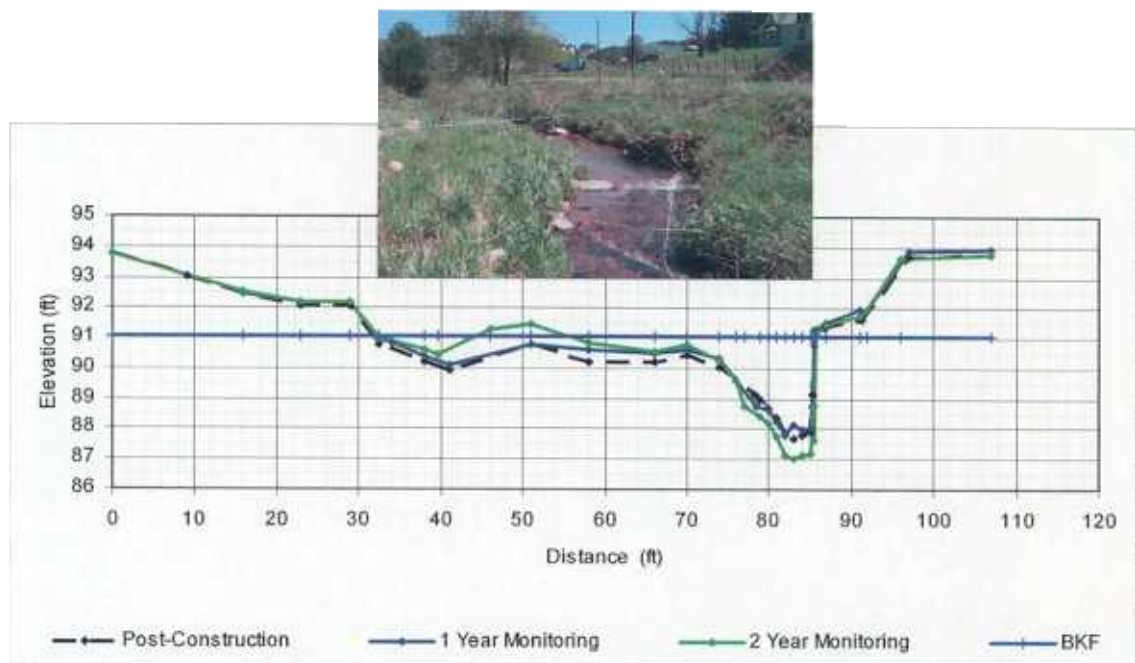
FIGURE 3.4. Cross-section station 7+19, pool.

**CROSS-SECTION 7+19 – pool (Figure 3.4):** This cross-section is located over a pool stabilized by root wads. The post-construction and 2002 monitoring cross-section surveys indicated no major changes in this cross-section. The 2004 survey shows a deepening of the pool by 1.17 ft and some deposition on the point bar, a result of the November 19, 2003 flood. Both banks exhibit the same elevations and breaks in slope from previous surveys.

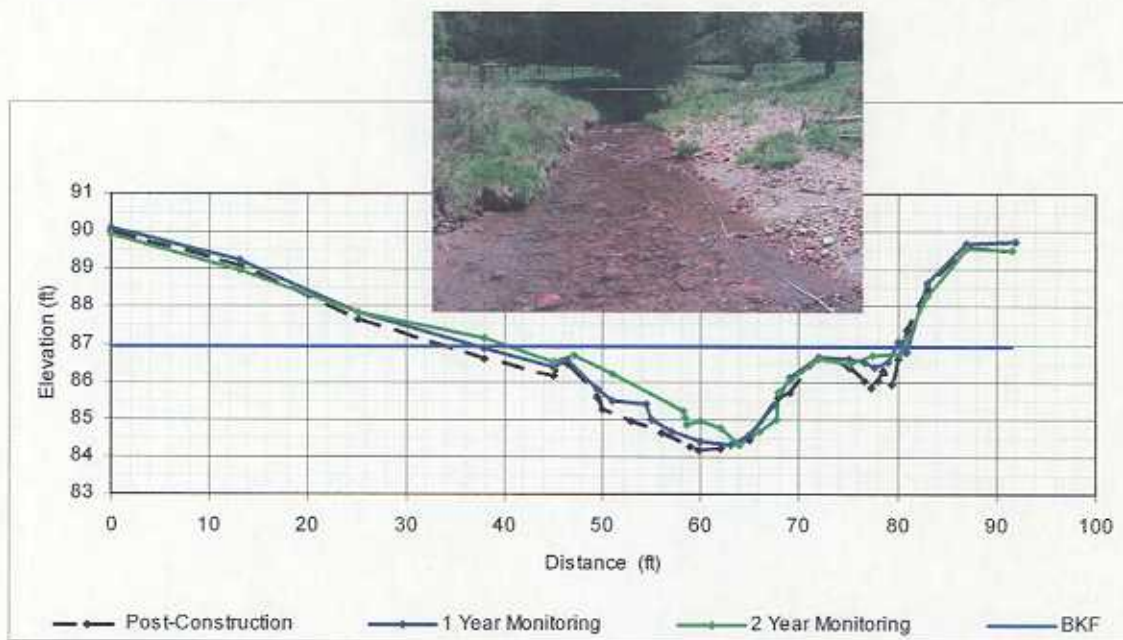
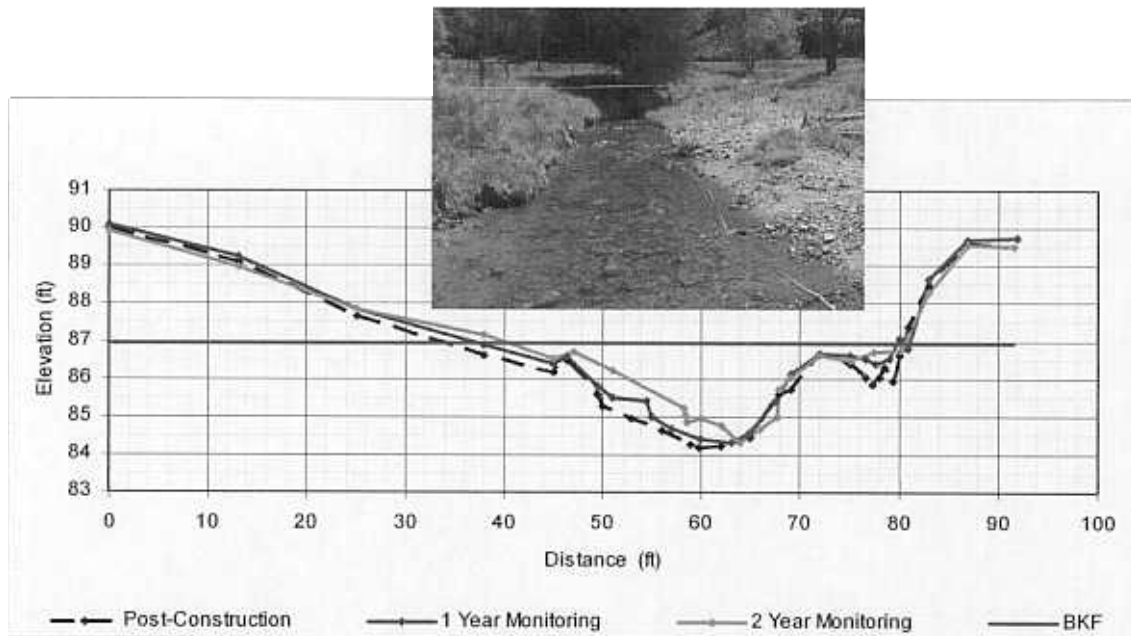
FIGURE 3.5. Cross-section station 10+35, riffle.

**CROSS-SECTION 10+35 – riffle (Figure 3.5):** This cross-section is located over a stable riffle immediately upstream of the second livestock crossing at longitudinal profile station 10+64. This was a wide, shallow riffle area and the purpose of this cross-section was to monitor the natural changes in the channel once livestock were excluded from the riparian zone. The width of the wetted perimeter indicates how much this channel has narrowed from 2001 to 2004. The wetted perimeter decreased from 18.3 ft in 2001, to 13 ft in 2002, and to 9.2 ft in 2004. The left bank has slowly widened creating a sloping bank, effectively narrowing the channel while the right bank has remained stable. As the vegetation along the slope of the left bank has become established, it has trapped materials suspended during bankfull events, effectively rebuilding the left bank with a stable slope. A wet spring seep is located from cross-section station 0+72 to 0+75.

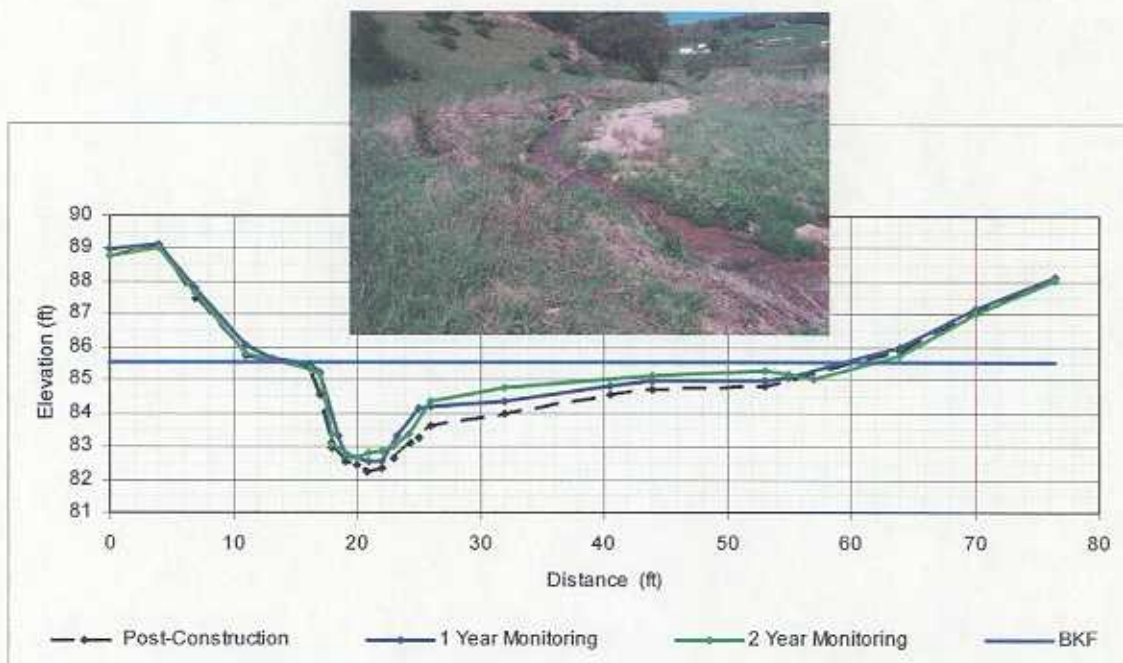
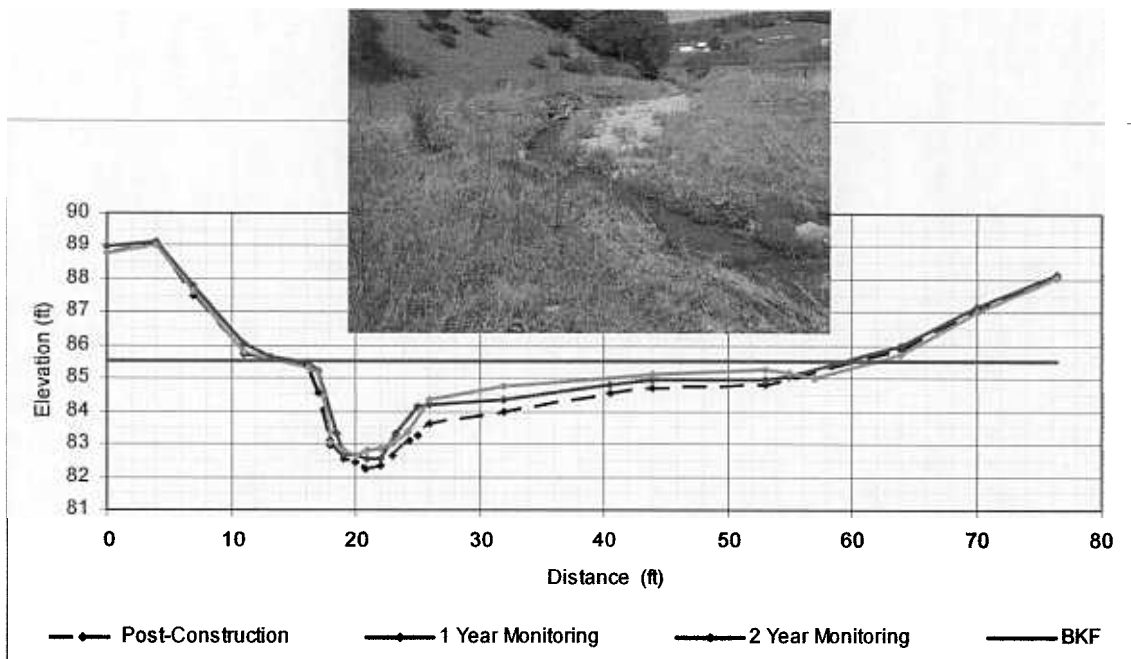
FIGURE 3.6. Cross-section station 11+68, riffle.

**CROSS-SECTION 11+68 – riffle (Figure 3.6):** This cross-section is located over a riffle which has a high left bank and long, sloping point bar on the right bank. There has been a noticeable change in the maximum height of the point bar, an increase of 0.78 ft from the post-construction survey. This is attributed to vegetation trapping stream bed materials during flood events. Since completion of the stream work at this cross-section, the thalweg has aggraded by 0.45 ft. Both banks exhibit the same elevation and breaks in slope.

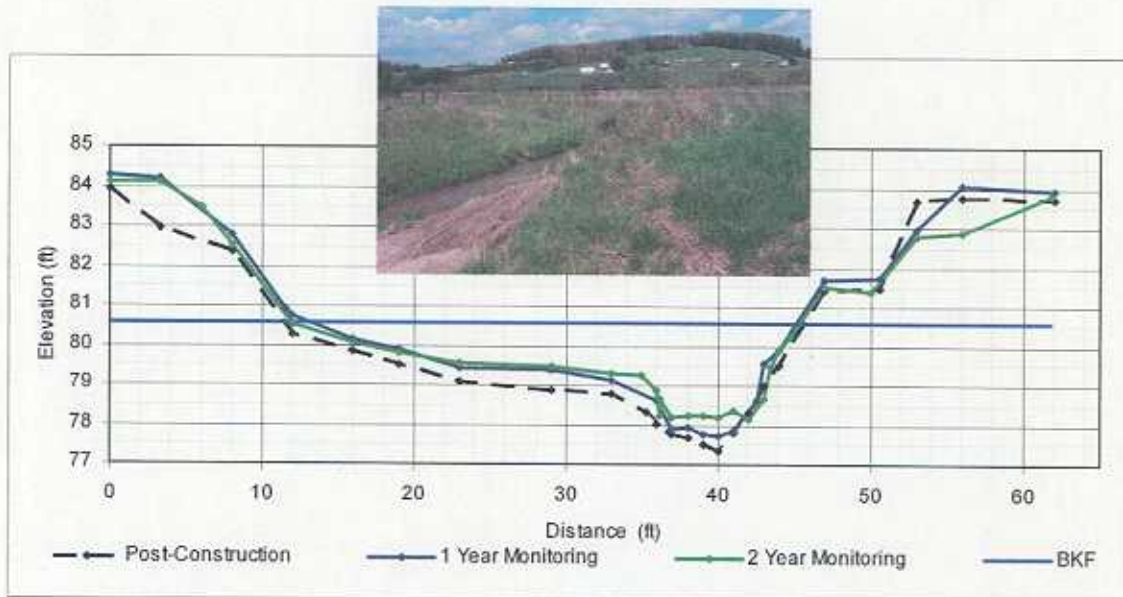
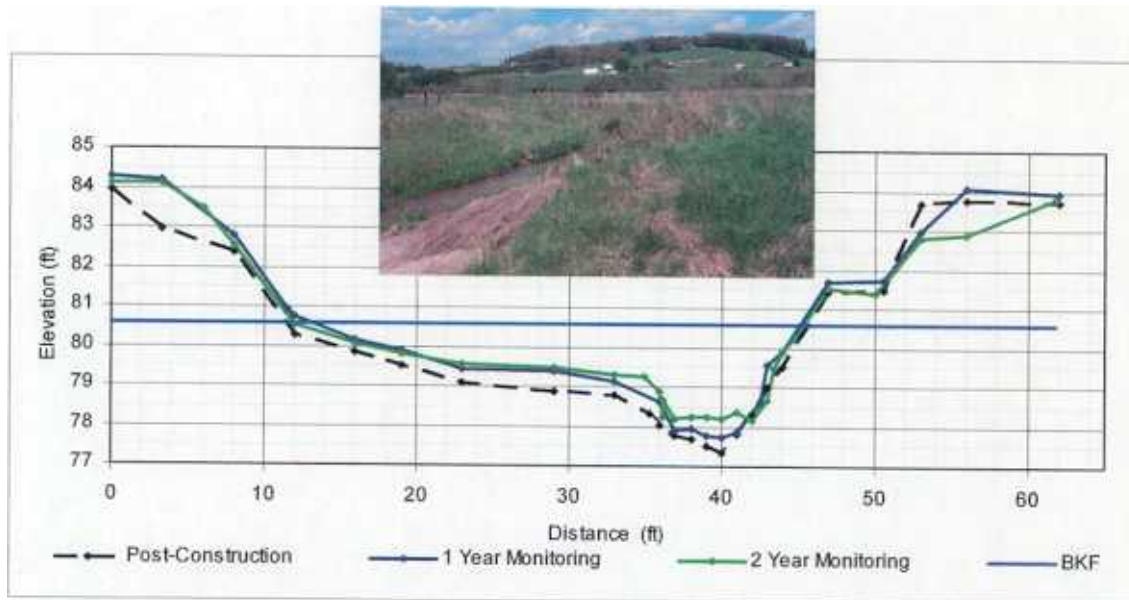
FIGURE 3.7. Cross-section station 16+81, riffle.

**CROSS-SECTION 16+81 – riffle (Figure 3.7):** This cross-section is located over a riffle which has a high right bank and long, sloping point bar on the left bank. There has been an increase in the height of the point bar by 0.53 ft and corresponding aggradations of the streambed by 0.81 ft. While there have been some adjustments to the channel since construction, there has been little lateral movement and the channel is stable. The unusual elevations for post-construction station 0+03.3 and 2 year monitoring station 0+56 is attributed to incorrect rod readings due to the rod beacon having to be hand held on the rod. This can be the only explanation for these odd elevations since the bank profiles have not changed during the monitoring period.

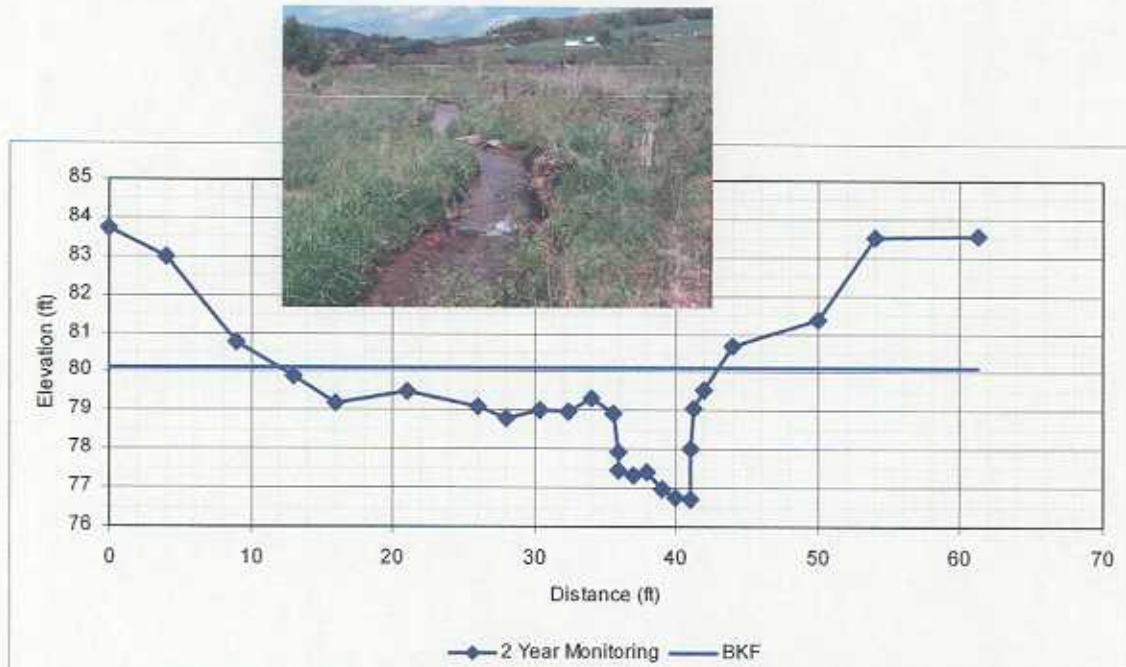
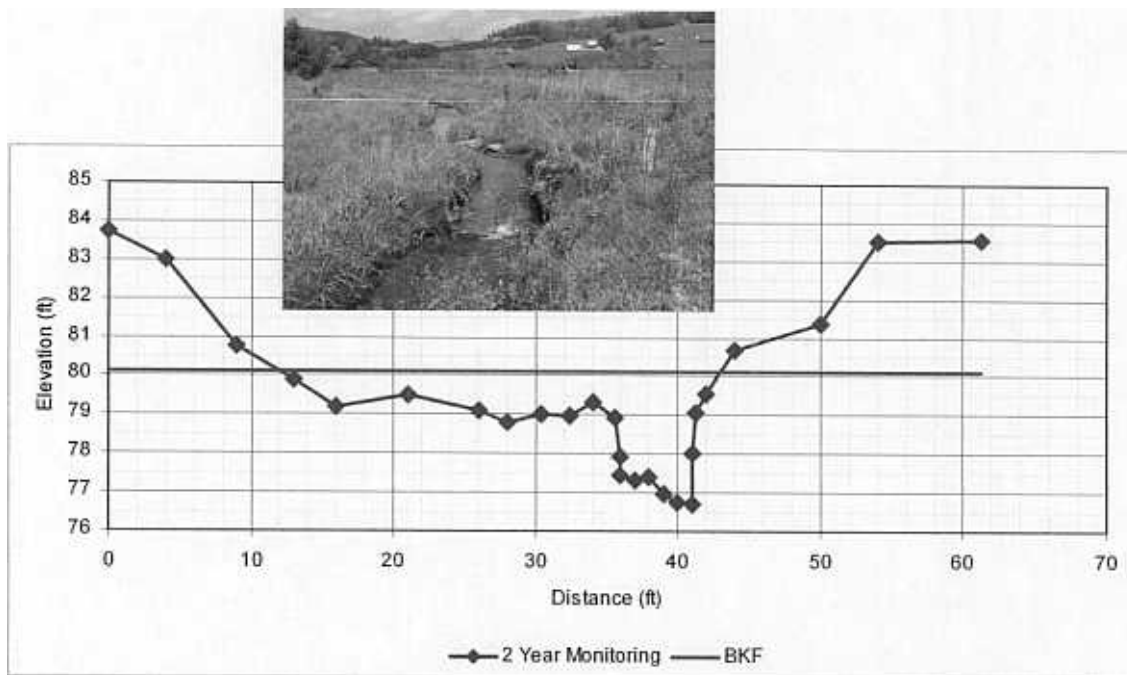
FIGURE 3.8. Cross-section station 17+08, pool, new cross section in 2004.

**CROSS-SECTION 17+08 – pool (Figure 3.8):** This cross-section was added to monitor the pool formed by root wads used to stabilize the bank. At the time of the 2004 survey, this area was not experiencing any stability problems.

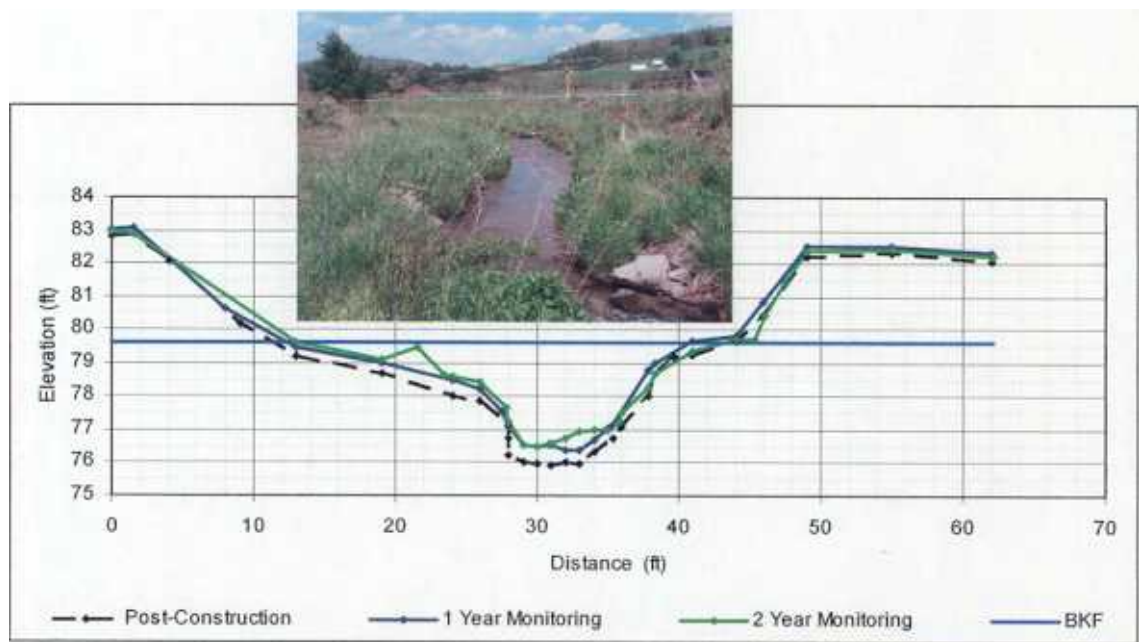
FIGURE 3.9. Cross-section station 17+57, riffle.

**CROSS-SECTION 17+57 – riffle (Figure 3.9):** This cross-section is located in a run/riffle complex below a rock weir. The tops of the banks show some ground settling has occurred since construction. There have been some minor adjustments to the bankfull and floodplain areas that have captured sediments during high water storm events. There has been a 0.56 ft aggradation of the channel thalweg between post-

construction and year 1 monitoring. This change in thalweg elevations is a result of stream channel adjustments following construction. The thalweg had a minor adjustment of + 0.10 ft between year 1 and year 2 monitoring period.

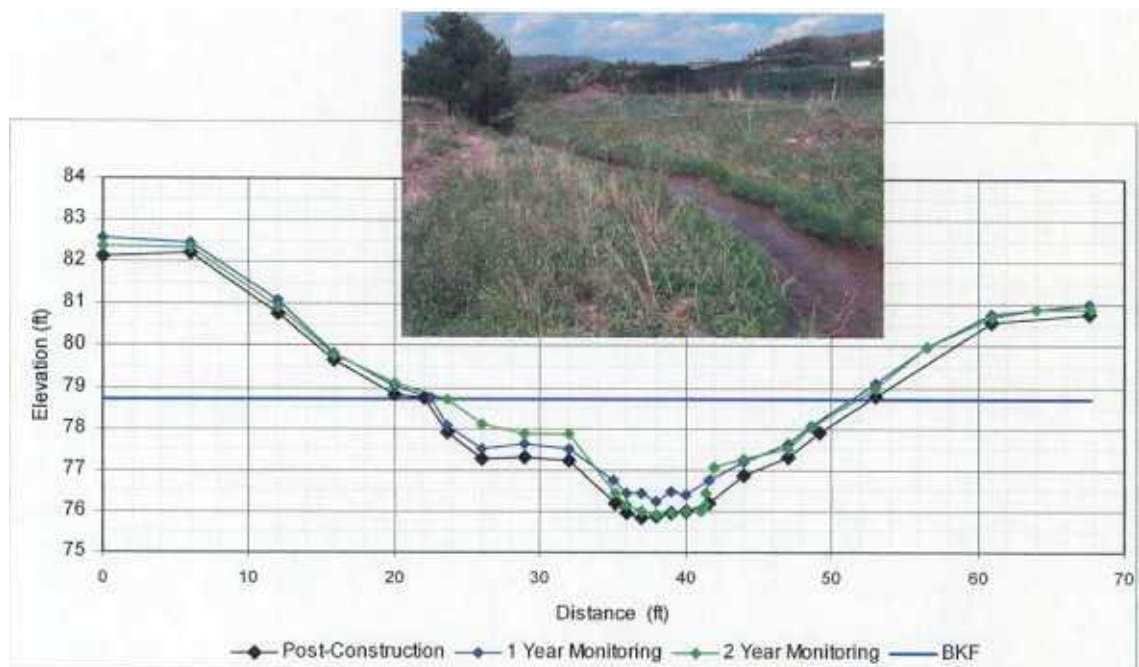
FIGURE 3.10. Cross-section station 18+42, riffle.

**CROSS-SECTION 18+42 – riffle (Figure 3.10):** This cross-section monitors a stable riffle that was not impacted by construction other than some minor grading along the top of the right bank. This untouched riffle shows the same sediment build-up along the banks as other cross-sections. The thalweg deepened by 0.31 ft from the year 1 to year 2 monitoring survey, bringing it back in line with the post-construction thalweg depth. Monitoring of this site shows that the stream thalweg will increase or decrease in elevation from year to year based on the number and magnitude of bankfull or greater events.

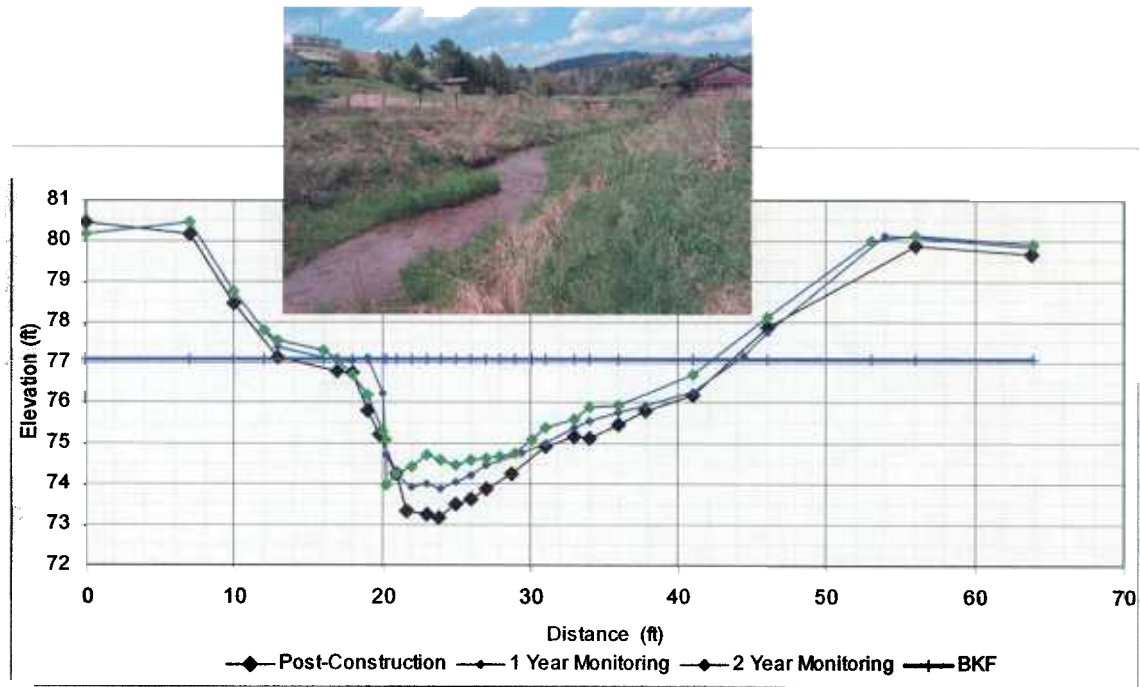
FIGURE 3.11. Cross-section station 20+80, pool.

**CROSS-SECTION 20+80 – pool (Figure 3.11):** This cross-section monitors a constructed pool stabilized with root wads below a rock weir. The right bank has aggraded slightly due to sediments being deposited in the bankfull and flood prone areas. The thalweg of the pool has aggraded, reducing the depth of the pool by 0.82 ft. It will be interesting to observe if this pool continues to fill or if it will scour out following the next bankfull event.

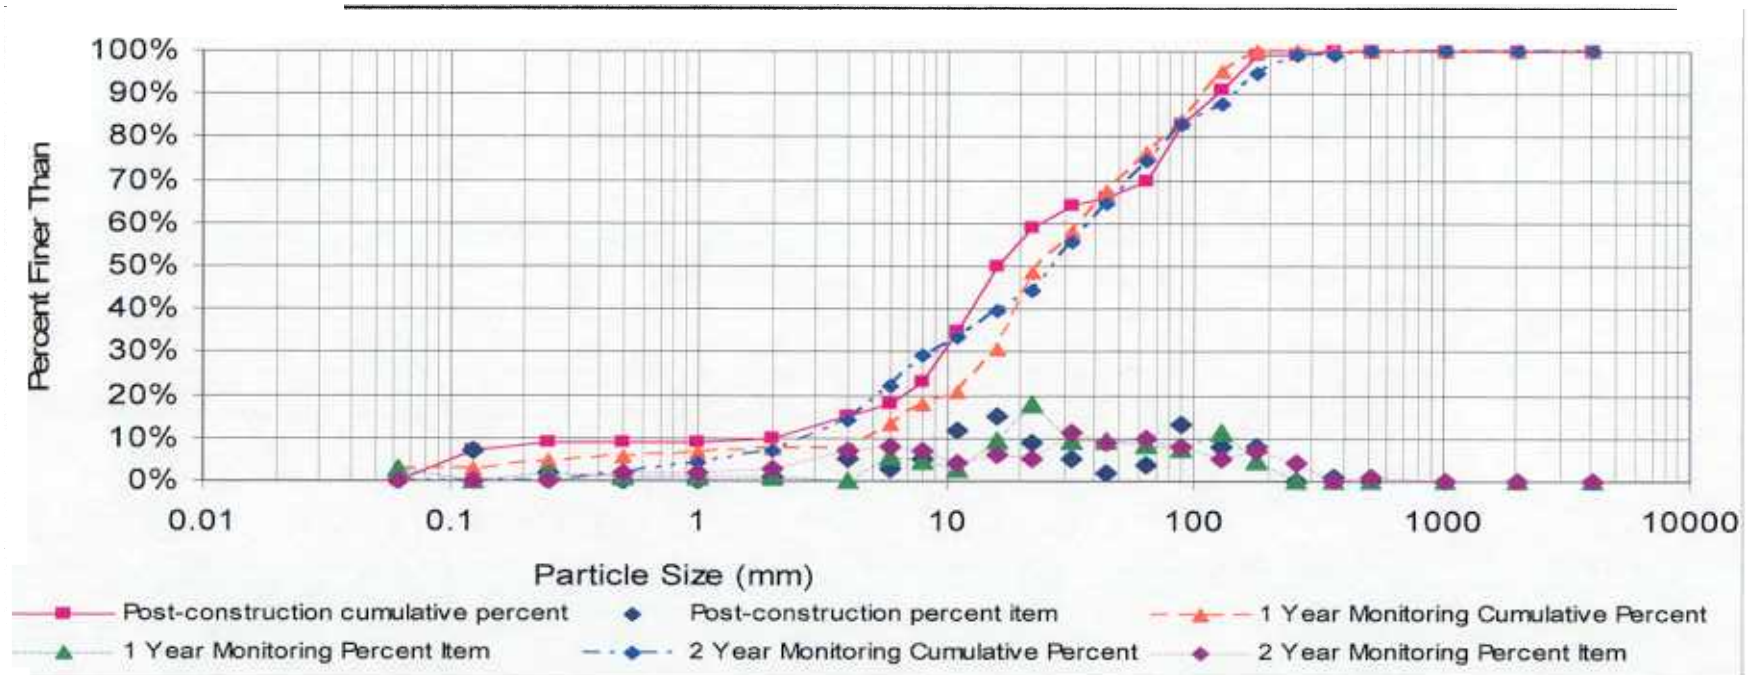
FIGURE 4. Pebble count comparisons, Bare site, UT Peak Creek, Watauga County, 2001-2004

Bed material analysis was conducted in a riffle at cross-section 18+42 (Figure 4). Pavement analysis (100 sample count wetted perimeter) has changed very little from post-construction to 2004. The D<sub>50</sub> observed in the pavement was 16 mm, 26 mm and 27 mm for post-construction year 1, and year 2 monitoring. Since the post-construction survey, the D<sub>50</sub> has changed from medium gravel to coarse gravel. The D<sub>95</sub> was 94 mm, 93 mm, and 98 mm for post-construction, year 1 and year 2 monitoring. The D<sub>95</sub> has remained in the small cobble particle size range. The bed material has exhibited little change since completion of the project.

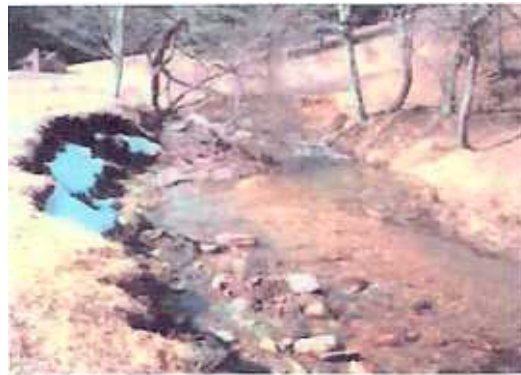
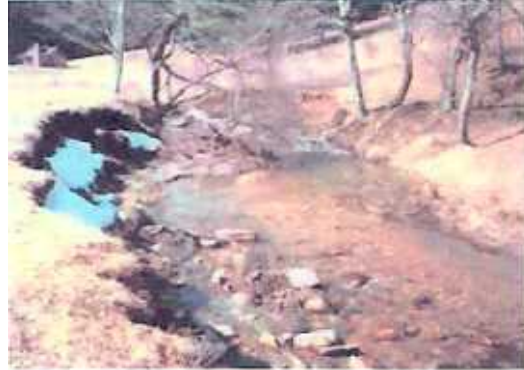
LUS stn. 5+50 eroding bank before work March 3, 2000

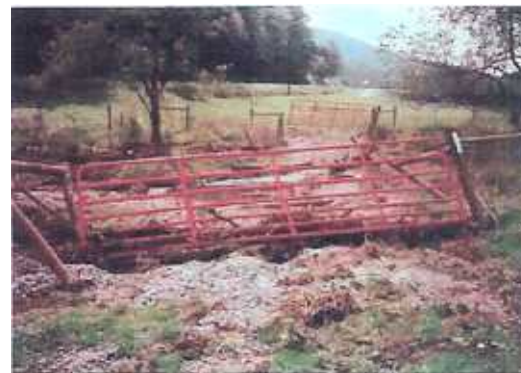
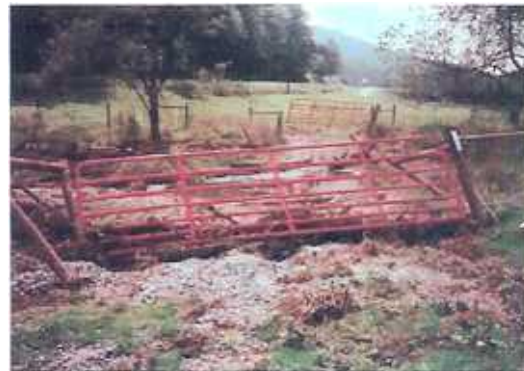
Stn. 5+60 damaged crossing flood September 27, 2002

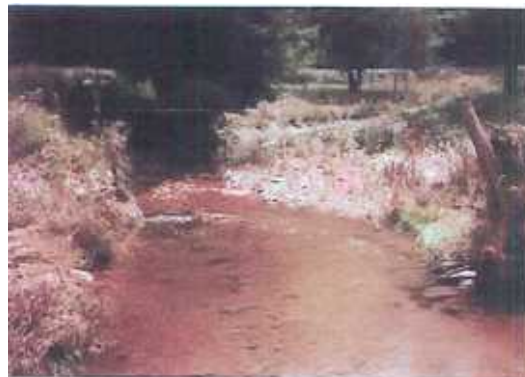
LUS XS 10+35 notice channel narrowing October 4, 2002

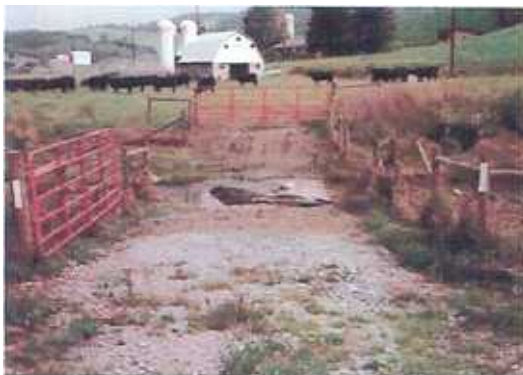
Livestock crossing stn. 10+54 after flood October 4, 2002
